Client:		
Title: 3Sixty Audio + Video		
Drawn By: EF	Scale: NTS	Date: 18/06/2012
Issued For: Rebuild		
Drawing No:	Rev:	1

THE UNIVERSITY of York

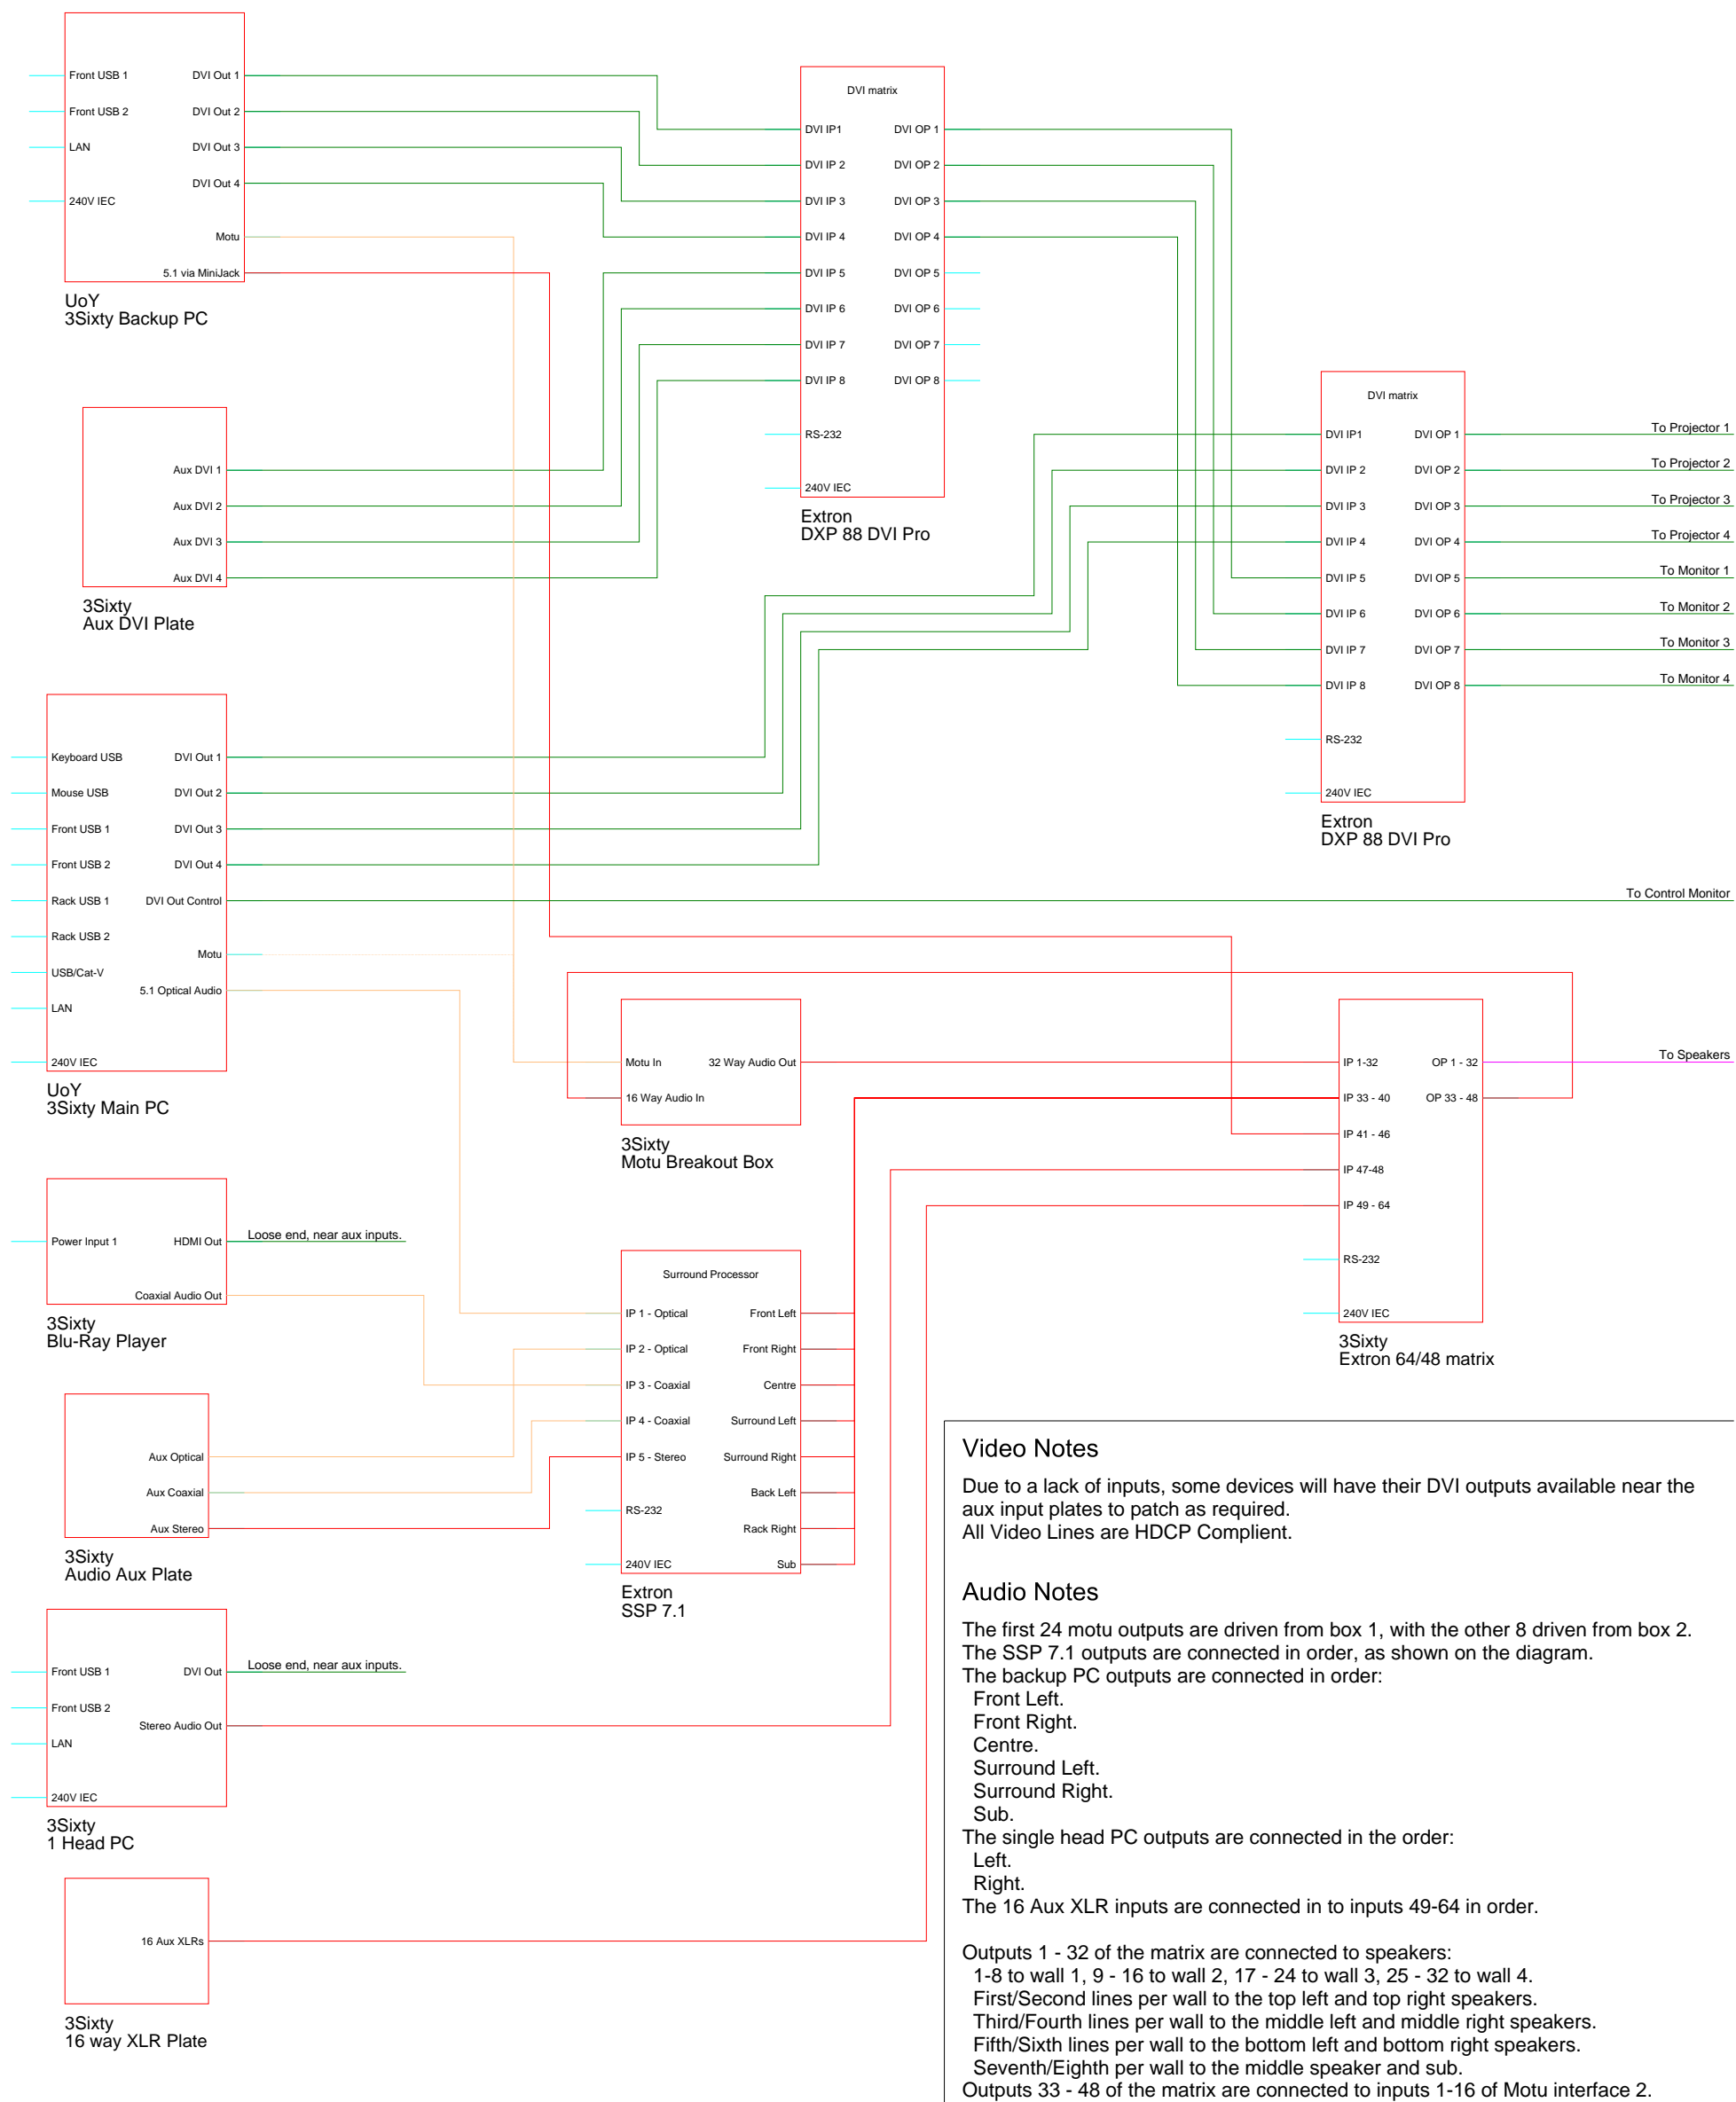
Video Notes
 Due to a lack of inputs, some devices will have their DVI outputs available near the aux input plates to patch as required.
 All Video Lines are HDCP Compliant.

Audio Notes
 The first 24 motu outputs are driven from box 1, with the other 8 driven from box 2.
 The SSP 7.1 outputs are connected in order, as shown on the diagram.
 The backup PC outputs are connected in order:
 Front Left.
 Front Right.
 Centre.
 Surround Left.
 Surround Right.
 Sub.
 The single head PC outputs are connected in the order:
 Left.
 Right.
 The 16 Aux XLR inputs are connected in to inputs 49-64 in order.

Outputs 1 - 32 of the matrix are connected to speakers:
 1-8 to wall 1, 9 - 16 to wall 2, 17 - 24 to wall 3, 25 - 32 to wall 4.
 First/Second lines per wall to the top left and top right speakers.
 Third/Fourth lines per wall to the middle left and middle right speakers.
 Fifth/Sixth lines per wall to the bottom left and bottom right speakers.
 Seventh/Eighth per wall to the middle speaker and sub.
 Outputs 33 - 48 of the matrix are connected to inputs 1-16 of Motu interface 2.
